**NORTH RIVER WATERSHED  
2007 MACROINVERTEBRATE ASSESSMENT  
(Franklin County, Massachusetts and Windham County, Vermont)**

***DEERFIELD RIVER WATERSHED ASSOCIATION***

September 2008

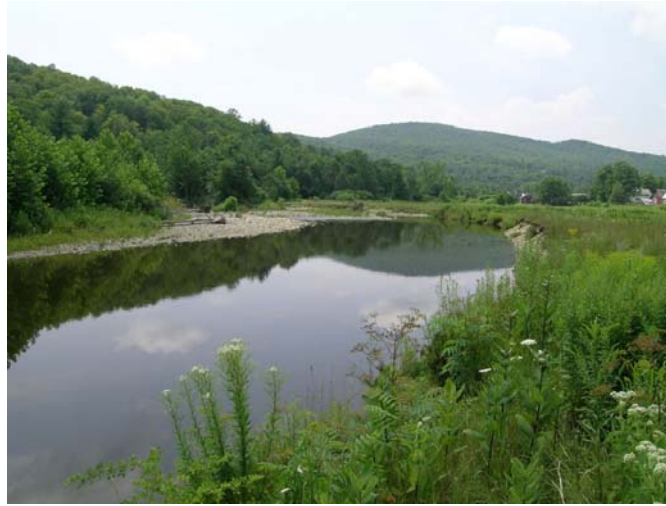
Figure 3. Widened section of the East Branch of the North River above Colrain center with low habitat diversity, eroding banks, and no riparian buffer along south side.

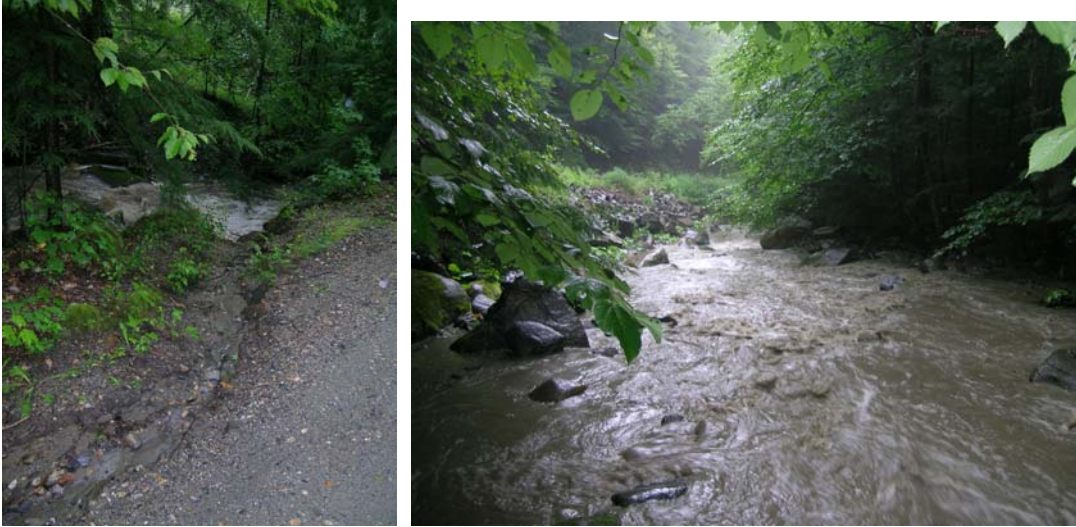
Figure 5. Taylor Brook receives heavy sediment loads from the adjacent unpaved road that parallels the upper portion of the brook (left), resulting in very turbid water full of suspended sediment during rain events (right). These photographs were taken in summer, 2007.

Despite extensive sediment deposition, Taylor Brook also scored as non-impacted relative to the Branch Brook reference reach (Table 7). While total taxonomic richness was lower (29) than that measured from the reference reach (35), an EPT richness of 22 was higher (Table 8). Although the overall score and individual metrics indicated little or no departure from expected conditions, it should be noted that the Taylor Brook reach was dominated by immature larvae of the sediment-tolerant mayfly genus, *Ephemerella*, and by the sediment-tolerant caddisfly, *Hydropsyche*. These two taxa represented nearly half of the individuals sampled from this site. This dominance by a few sediment-tolerant taxa suggests that elevated sediment loads have altered community structure in Taylor Brook, but not to the extent that significant biological impairment is occurring.

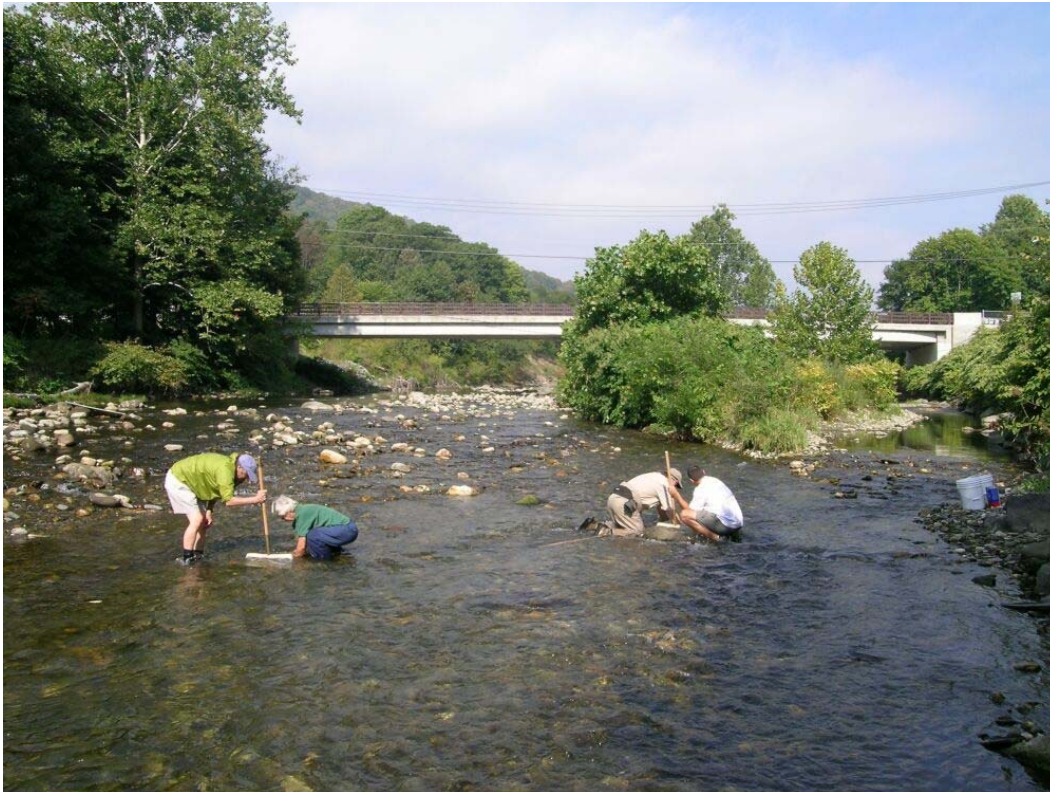
Figure 6. Area sampled at NORM02 relative to location of Barnhardt plant effluent location of entry into the mainstem (small channel on right).

Site NORM02 occurs immediately below the Barnhardt Plant in Griswoldville, which discharges treated wastewater into the North River under a NPDES permit. Although NORM02 occurs below the plant, the site was located *upstream* of the point at which the treated effluent enters the mainstem because the effluent is conveyed for nearly 100 m down a side channel before entering the main river flow downstream of the riffle area sample for this assessment.

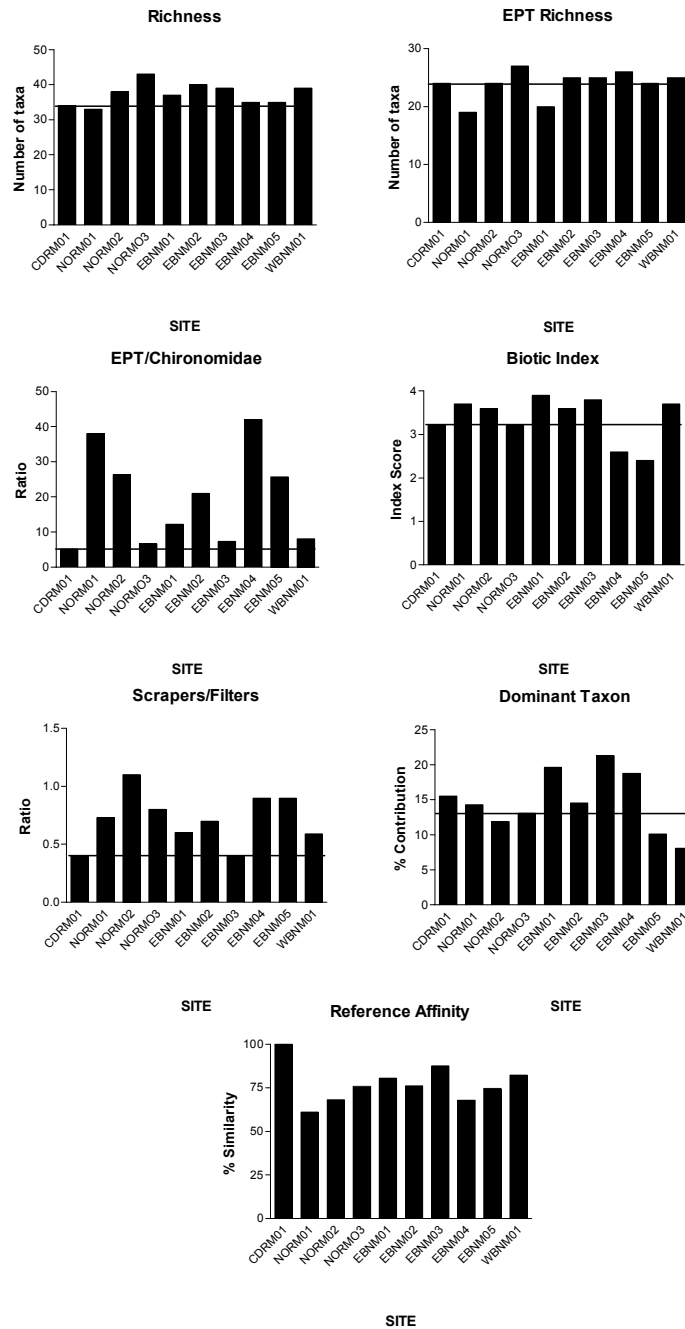
Figure 7. Metric attribute values calculated from macroinvertebrate samples collected from North River mainstem sites in September 2007. Black horizontal lines indicate value of each attribute at the reference site on the Cold River (CDRM01).
