### SOUTH RIVER WATERSHED 2006 MACROINVERTEBRATE ASSESSMENT

(Franklin County, Massachusetts)

### DEERFIELD RIVER WATERSHED ASSOCIATION

May 2007

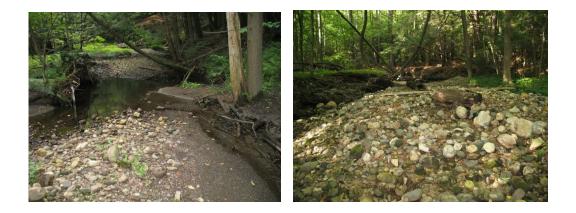
Figure 3. The upper South River upstream of Baptist Church Road (in and above sampling reach SORM08) was characterized by frequent areas of heavy fine sediment deposition (left photo) and channel aggradation (right photo), suggesting a highly modified hydrology.

South River tributaries supported less favorable habitat conditions relative to the Chapel Brook reference reach (CPBM01), ranging from a low rapid habitat assessment score of 72 from the upper South River in Ashfield (SORM08) to a high of 138 from lower Creamery Brook above the confluence with the South River (Table 4). Habitat conditions in SORM08 were poorest among all reaches sampled in the watershed. This reach, occurring at the lower end of the section of the South River flowing through the town Ashfield, was characterized by large amounts of fine sediment deposition, unstable banks, and a channel with frequent areas of aggradation and scour (Figure 3). A short section of this length of river flows through a forested tract of land, but only a short

distance upstream, the brook flows is tightly straddled by residential land use through the town of Ashfield, where riparian zones are narrow and not well vegetated.

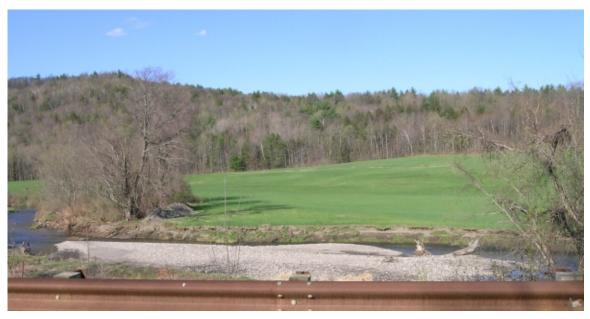
Figure 7. Photograph of severely eroding river banks along the South River north of Conway. This photo was taken in spring 2007.

Maintenance of healthy benthic communities and therefore overall ecological health of the South River watershed rests on continued stewardship of these aquatic resources and adjacent riparian habitats. Prevention of further loss of mature riparian zones in the watershed is necessary to ensure the continued health of these communities. Even better, restoration of degraded riparian areas within the watershed – along the mainstem of the South River above and below Conway, in particular – would result in benefits to these resources such as reduced sediment loads, increased channel stability, and increased amounts of woody debris and food materials for aquatic life.
