Water Quality Monitoring

2018 Program Report

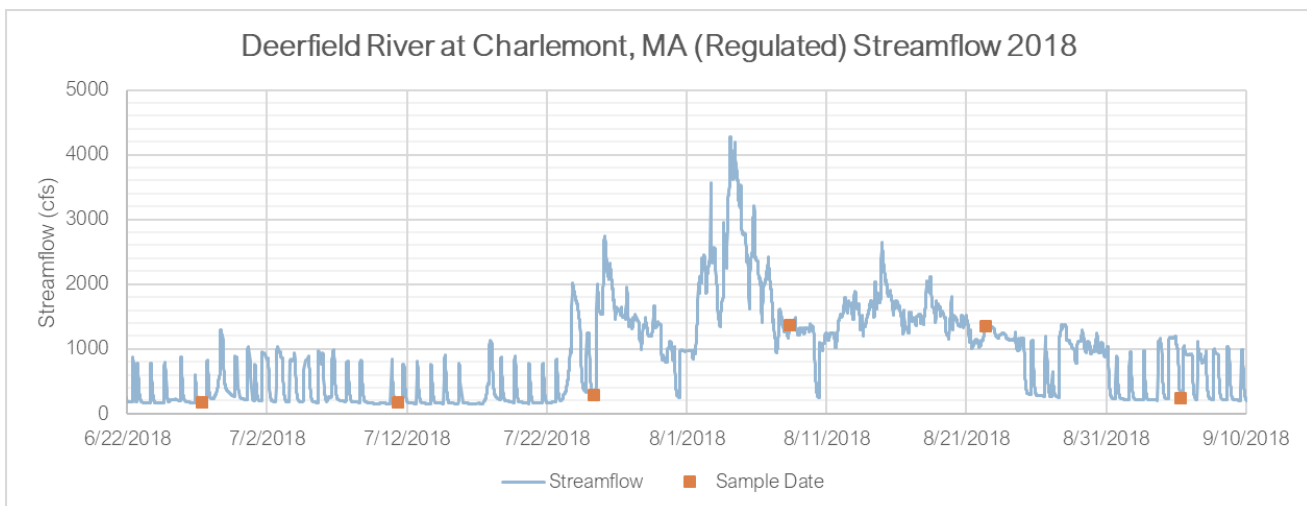
FIGURE 2 - DEERFIELD RIVER STREAMFLOW SUMMER 2018

Volunteers are required to note the level and type of flow at each site at the time of sampling, presented above. These observations are inherently subjective, based on individual observations at specific sites. They cannot be corroborated by any gages due to the highly regulated nature of the Deerfield River. There are no gauges on the North Branch Deerfield River. There are two USGS gages in the portion of the river that is subjected to daily hydropower and recreational releases. The streamflow recorded at the upstream gage (downstream of MA-DFR_26.7) and time sampled are depicted below. Samples tended to be collected during low flows in the mornings, but high flows this year resulted in the river not being drawn down daily during August.

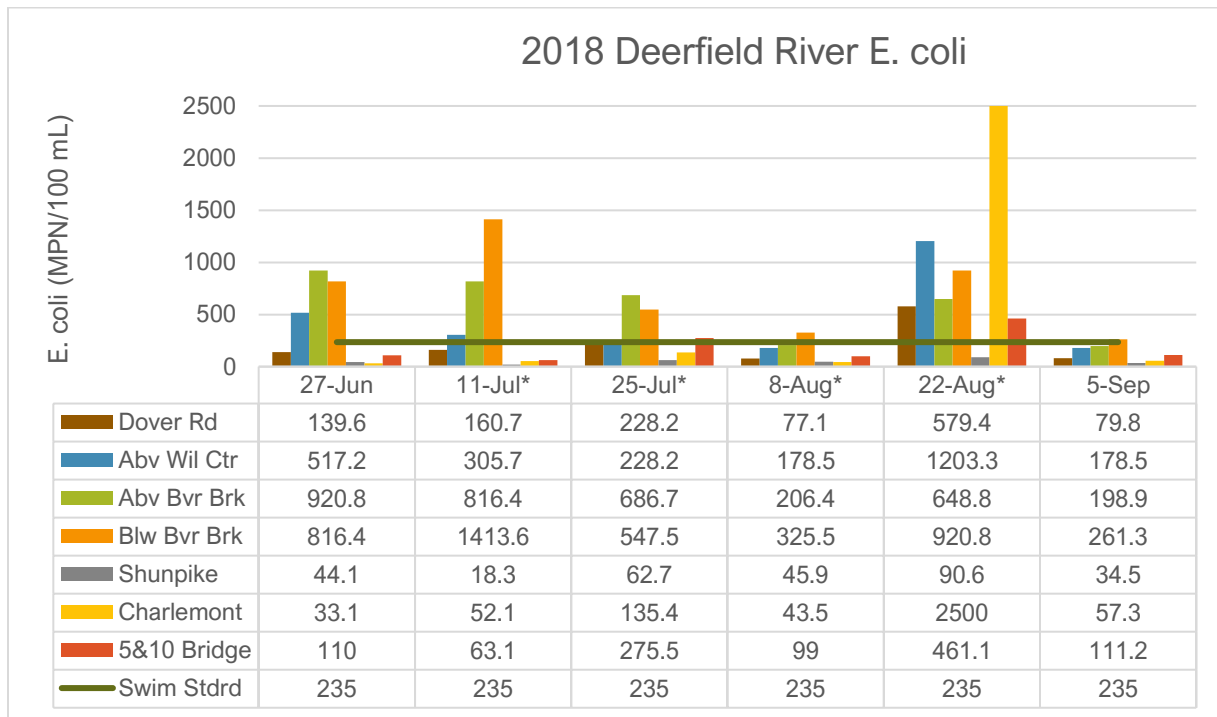
* Wet weather (>0.1" rain) in 24 hours prior to sampling

The furthest upstream North Branch Deerfield site, Dover Rd, tended not to exceed the swimming standard except for in the wettest weather (Aug 22). The rest of the North Branch sites, Above Wilmington Center, Above Beaver Brook, and Below Beaver Brook had high levels in wet weather and sometimes during dry weather. It also appears that Beaver Brook usually contributed to increased *E. coli* levels in the North Branch in four out of six sampling events. Results from the Beaver Brook site can be found in the Other Tributaries section.

The mainstem sites, Shunpike Rest Area, Charlemont Center, and 5&10 Bridge, overall had much lower bacteria levels than the North Branch sites. Shunpike Rest Area always had very low readings even in extremely wet weather. Charlemont Center exceeded the swim standard only on the wettest day (Aug 22). The furthest downstream site at the 5&10 Bridge had the highest bacteria levels of the three mainstem sites but still only exceeded the swim standard twice during wet weather days.

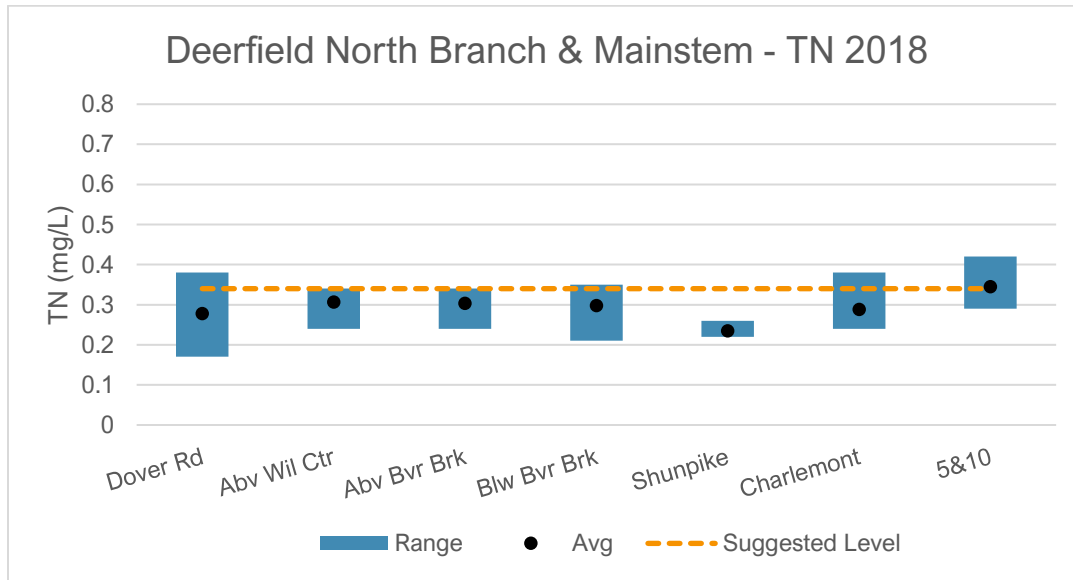
The averages for all sites were well below the VT standard of 5.0 mg-N/L. Only the lowest mainstem site at the 5&10 Bridge in Greenfield exceeded the EPA’s current suggested level of 0.34 mg-N/L. The North Branch Sites (Dover Rd, Above Wilmington Center, Above Beaver Brook, and Below Beaver Brook) are in a predominantly agricultural area that transitions into more urban land use.

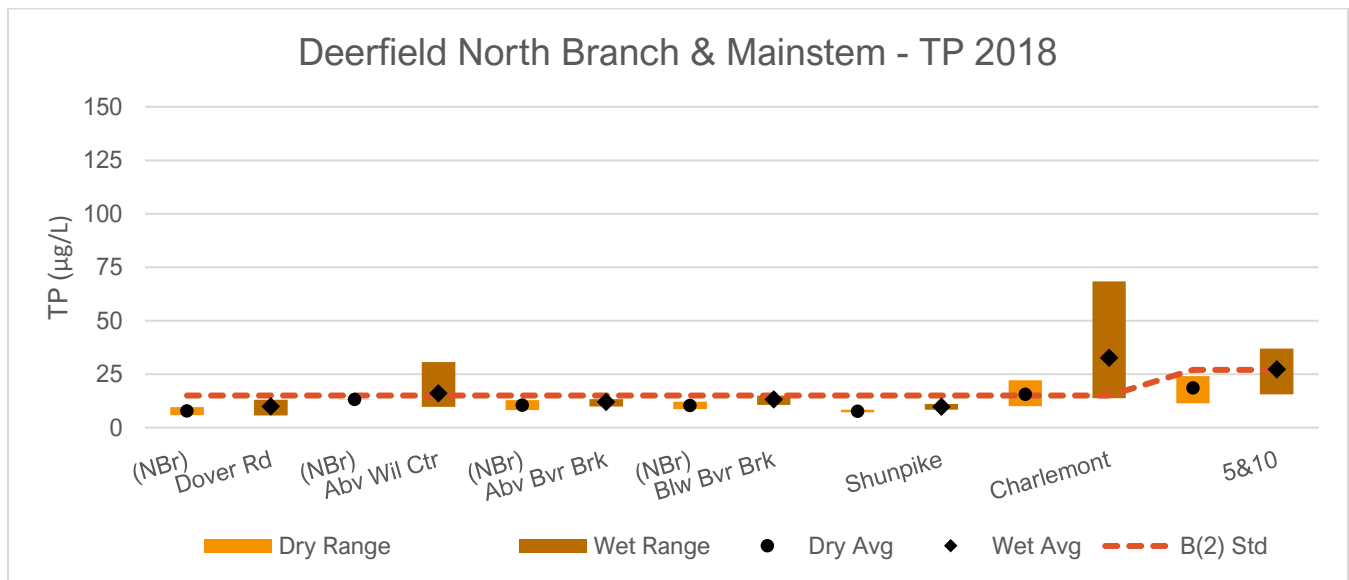
All site averages met the VT standard for cold water streams of 15 µg-P/L (27 µg-P/L for the one warm water site) when sampled during dry weather. The North Branch site Above Wilmington Center and the mainstem sites at Charlemont Center and the 5&10 Bridge exceeded their standards when sampled during wet weather. Between the Shunpike Rest Area site and the Charlemont Center site are the confluences with the Chickley River (results below) and the Mill Brook (not sampled) and the discharge from the Charlemont wastewater treatment plant. DRWA is planning to sample the Mill Brook in 2019 to better understand where nutrient and bacteria contributions in Charlemont center are coming from during wet weather.

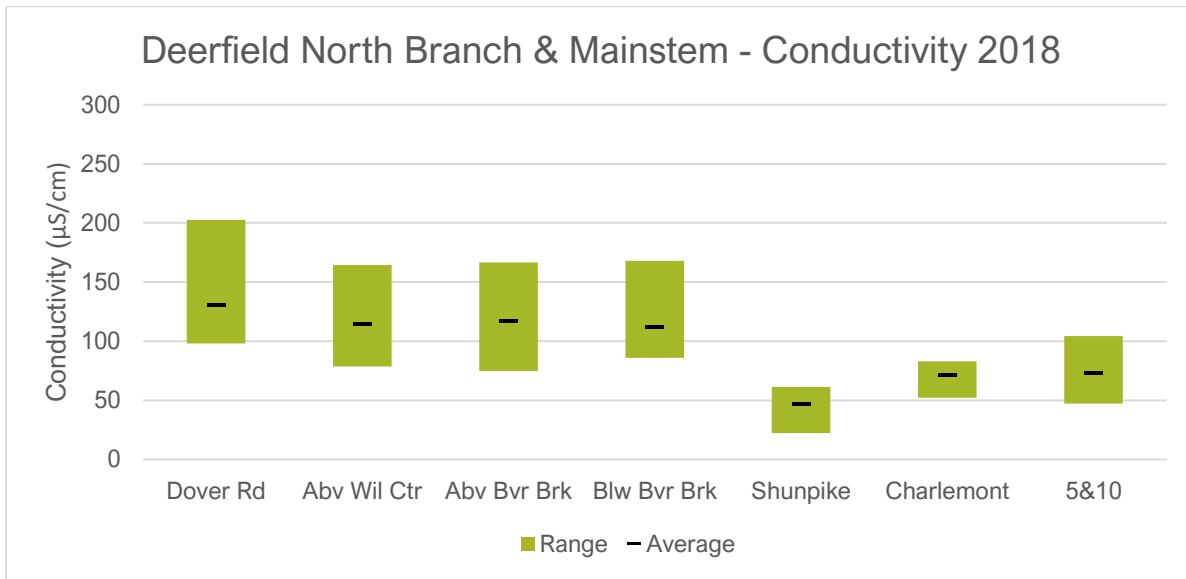
There is no standard conductivity in either state. The North Branch sites all have higher conductivity levels than the mainstem sites. In 2017, the Dover Rd site also had the highest chloride levels which may be due to its proximity to the Mount Snow ski area and the increased use of road salt to accommodate winter recreation.

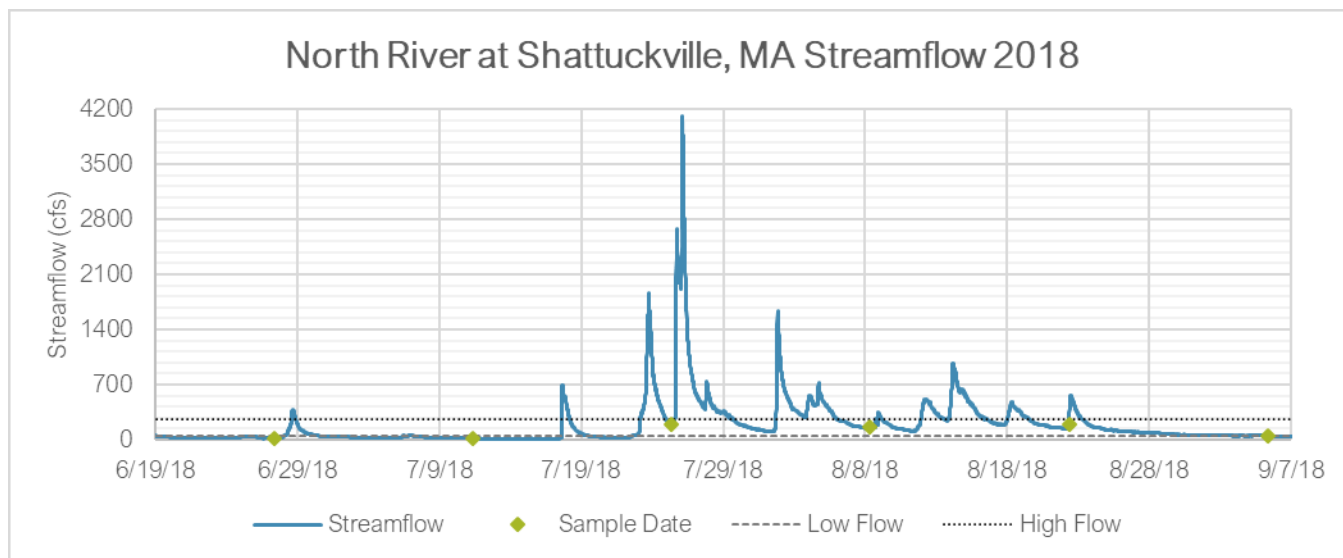
FIGURE 3 - NORTH RIVER STREAMFLOW SUMMER 2018

Volunteers are required to note the level and type of flow at each site at the time of sampling, presented above. These observations are inherently subjective, based on individual observations at specific sites. There is a USGS gage located downstream of all the sites on the mainstem North River. Based on flows measured at the gage, 6/27, 7/11, and 9/5 had low flows and 7/25, 8/8, and 8/22 had moderate flows.

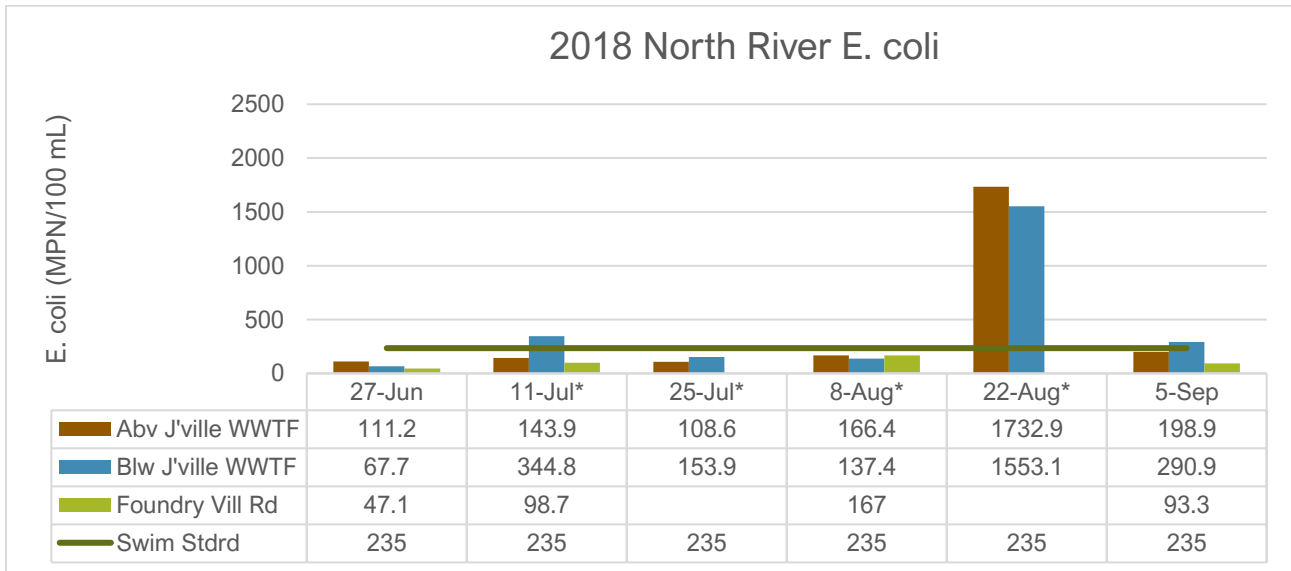
* Wet weather (>0.1" rain) in 24 hours prior to sampling

The site above the Jacksonville Wastewater Treatment Facility (WWTF) only exceeded the swim standard in the heaviest rain (August 22). The site below the Jacksonville WWTF sometimes exceeded the swim standard. The site off of Foundry Village Rd was not sampled during high water due to safety concerns, so it is unclear how that site would have tested after heavy rains but otherwise did not exceed the swim standard.

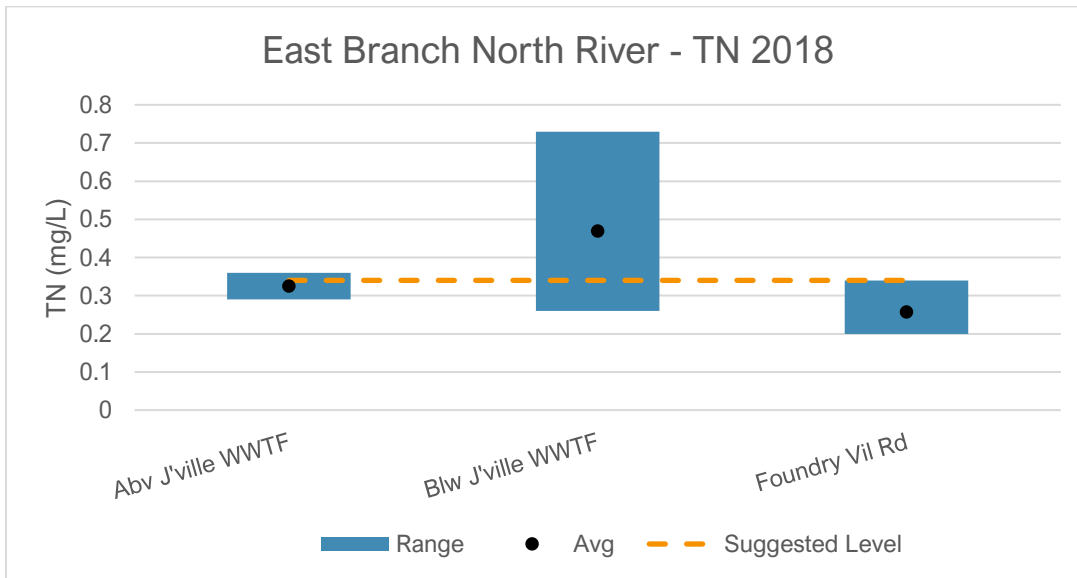
The averages for all sites were below the VT standard of 5.0 mg-N/L. The only site that exceeded the EPA suggested level of 0.34 mg-N/L was the site below the Jacksonville WWTF. The elevated nitrogen at the site below the Jacksonville WWTF is likely due to the facility discharge.

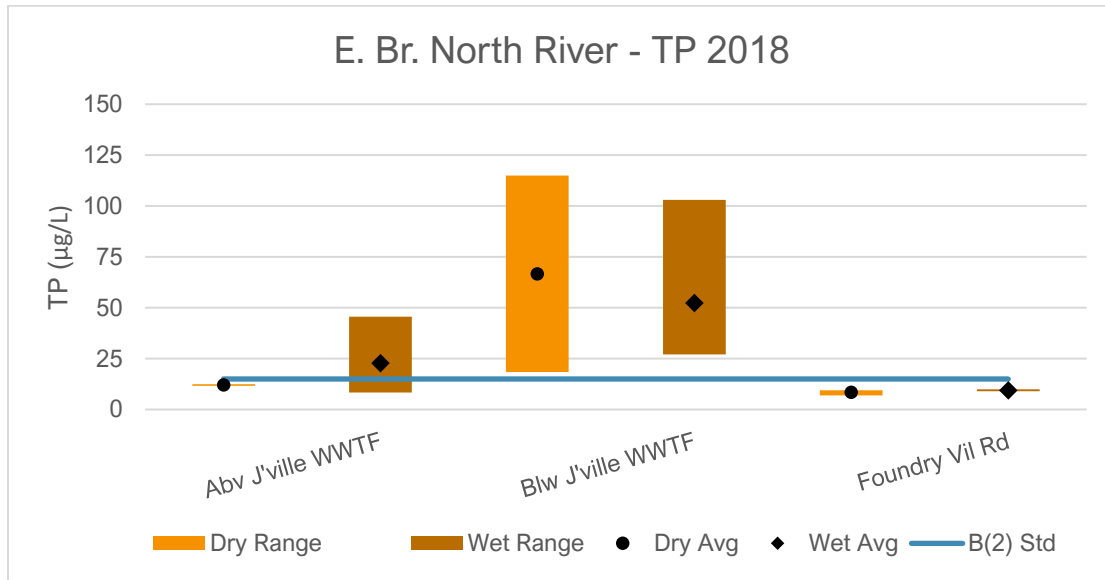
The site above the Jacksonville WWTF only exceeded the VT standard for cold water streams of 15 µg-P/L during wet weather. The site below the Jacksonville WWTF always exceeded the standard, which is likely from the wastewater treatment facility discharge. The site off Foundry Village Rd was not sampled during higher flows due to safety concerns, so it is difficult to understand if that site would have reacted during the two heavy rain days.

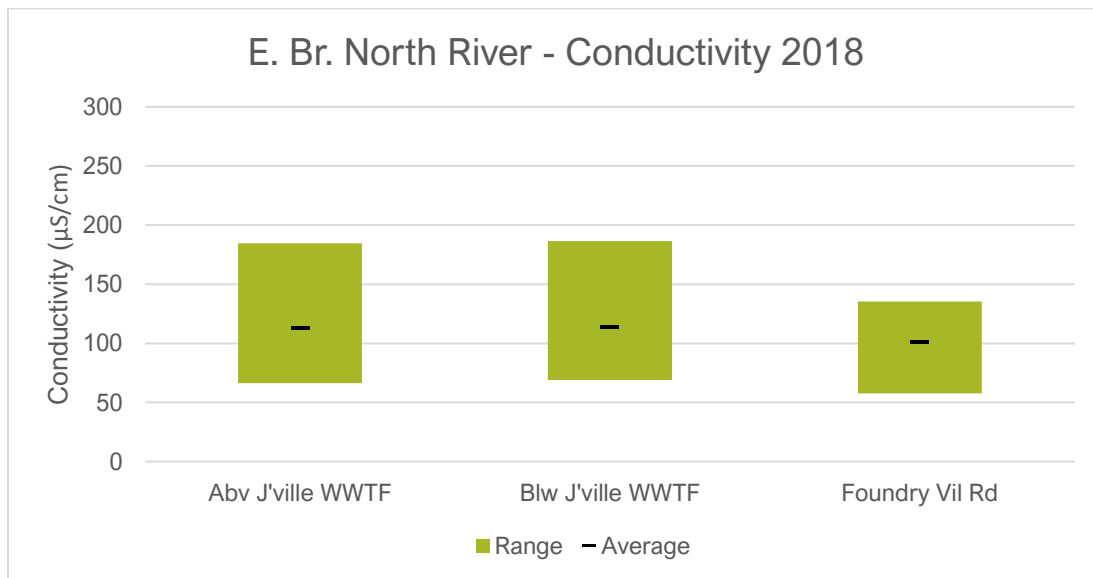
There is no standard conductivity in either state. The Foundry Village Road site had the lowest conductivity but was not sampled two days during higher flows due to safety concerns. No site stands out as concerning.

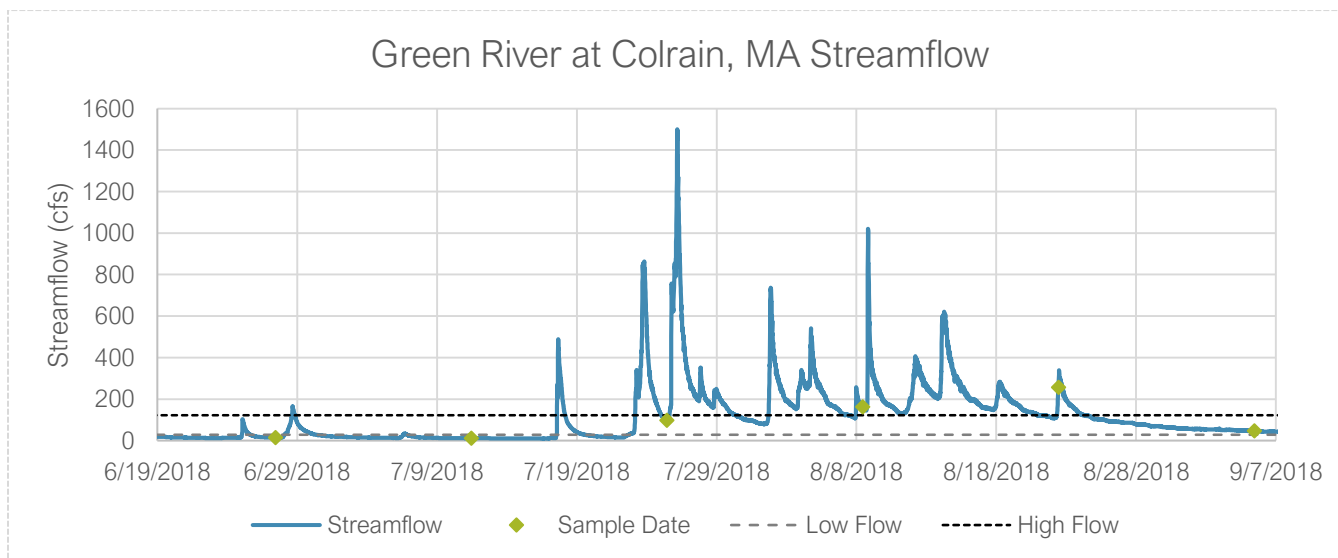
Volunteers are required to note the level and type of flow at each site at the time of sampling, presented above. These observations are inherently subjective, based on individual observations at specific sites. There is a USGS gage located between the Vermont and Massachusetts sites. Based on flows measured at the gage, 6/27 and 7/11 had low flows; 7/25 and 9/5 had moderate flows; and 8/8 and 8/22 had high flows.

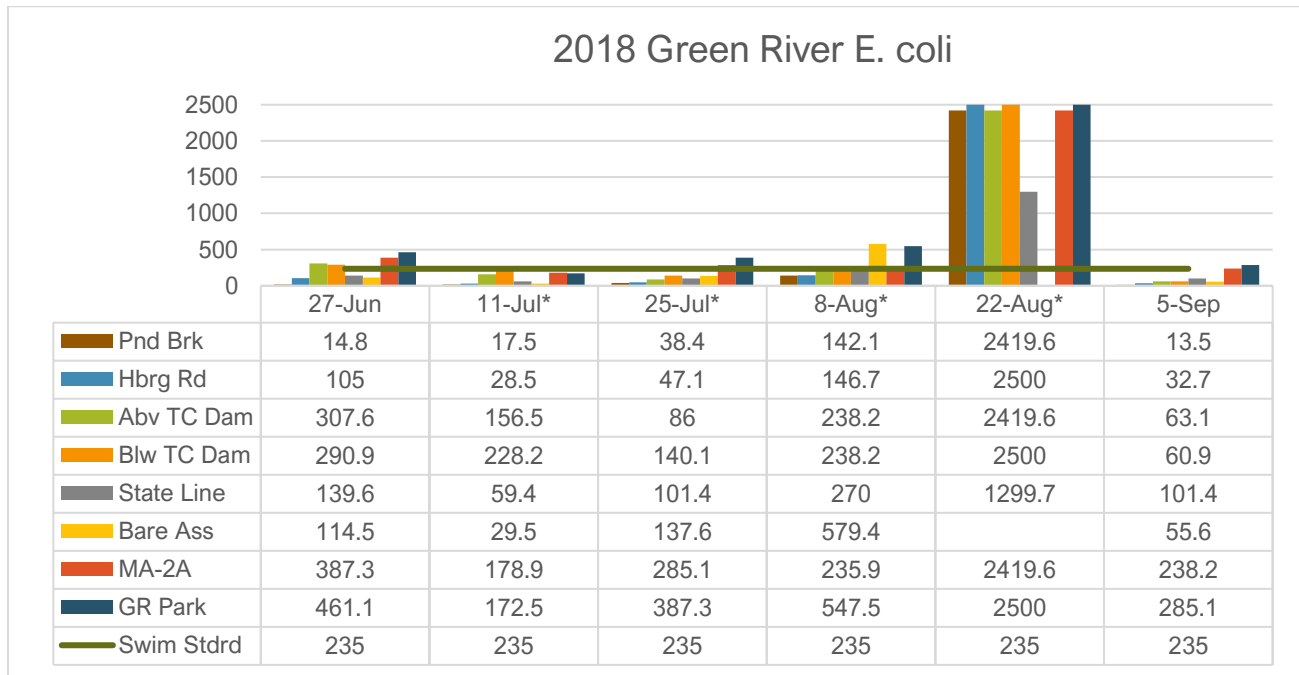
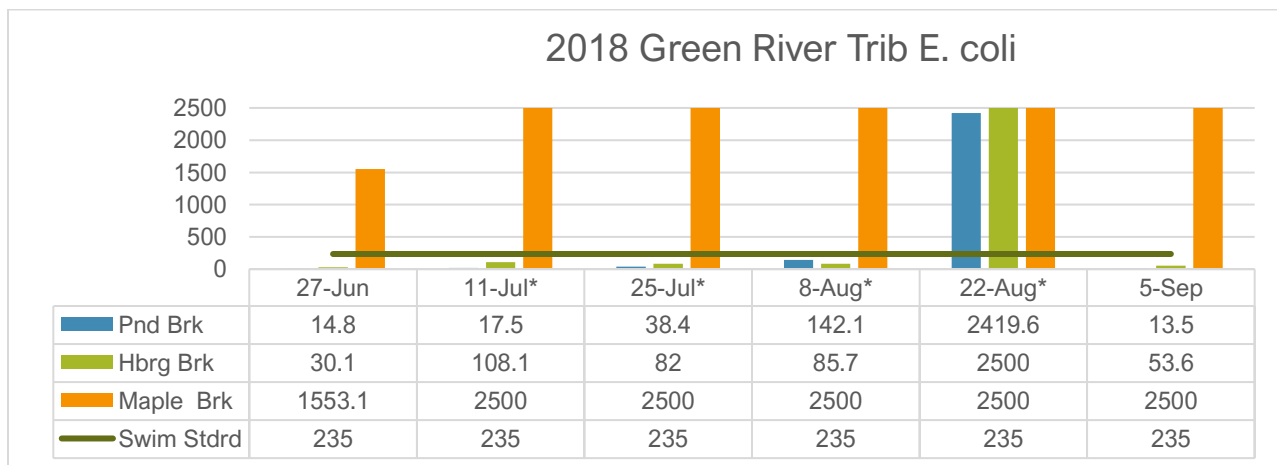
* Wet weather (>0.1" rain) in 24 hours prior to sampling

The mainstem Green River sites upstream of Greenfield proper (Bare Ass Beach and up) as well as the headwater tributaries (Pond Brook and Hinesburg Brook) tended to be below the swim standard in dry weather and mostly in wet weather as well. The notable exception is August 22 when the Green River valley received a significant amount of rain resulting in extremely high flows and *E. coli* levels to match. Greenfield sites (MA-2A, Green River Park, and Maple Brook) tended to always be in exceedance of the recreation standard. Maple Brook is buried under Greenfield and is directly connected to much of the town's stormwater infrastructure before emptying into the Green River.

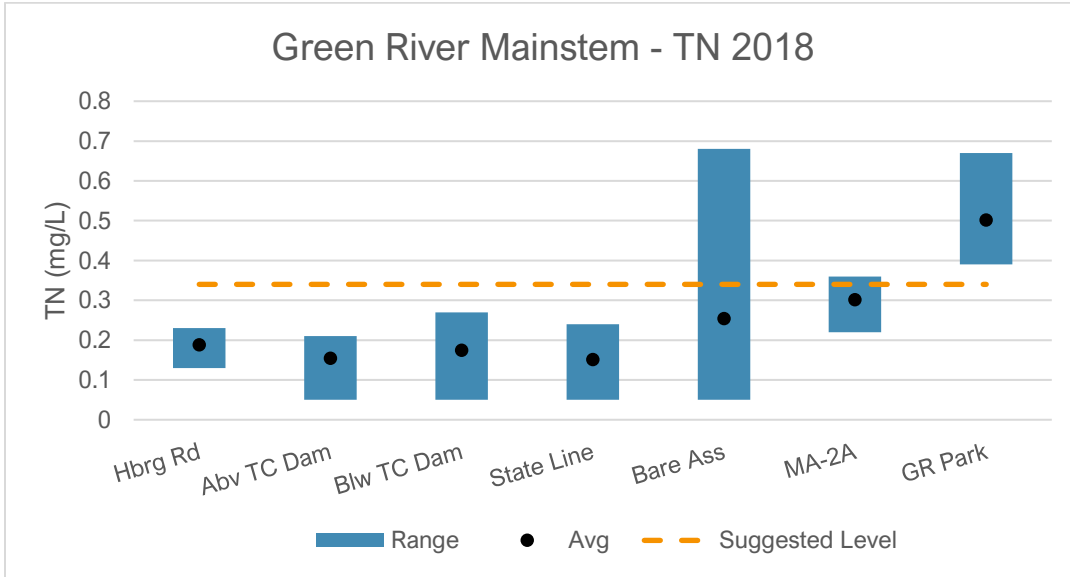
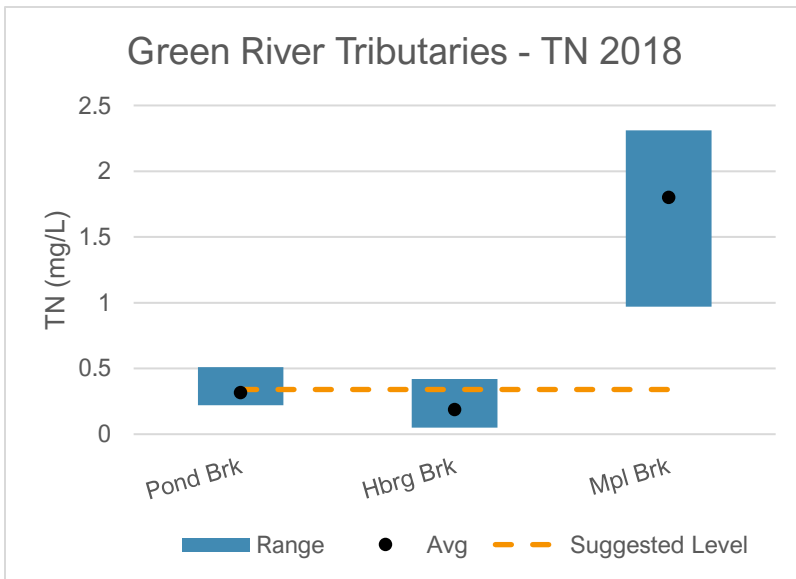
The averages for all sites were well below the VT standard of 5.0 mg-N/L. Maple Brook and the Green River Park were the only sites with averages above the EPA suggested level of 0.34 mg-N/L and no recorded values below that suggested.

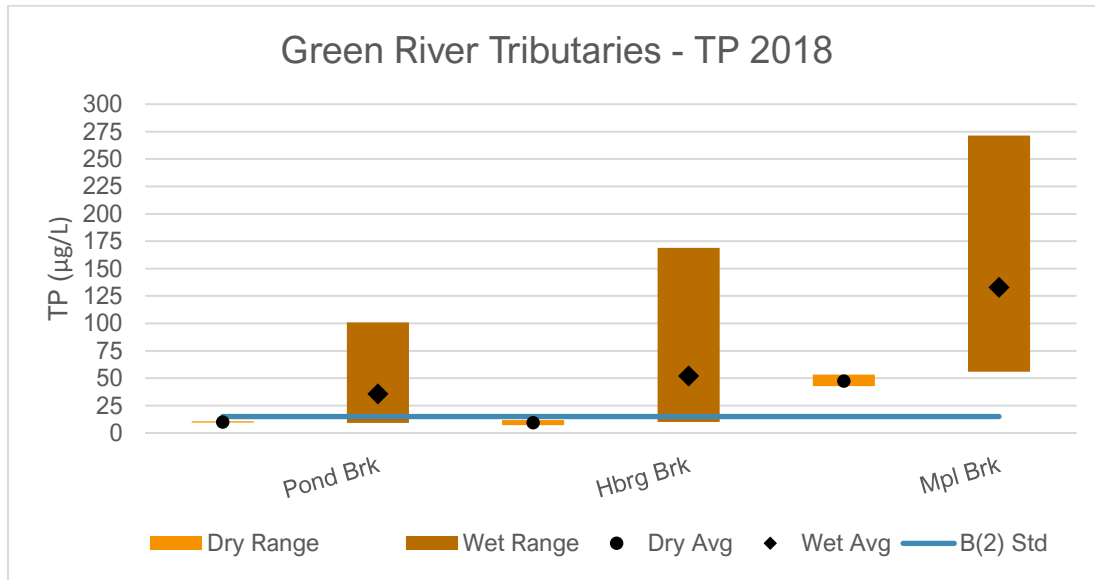
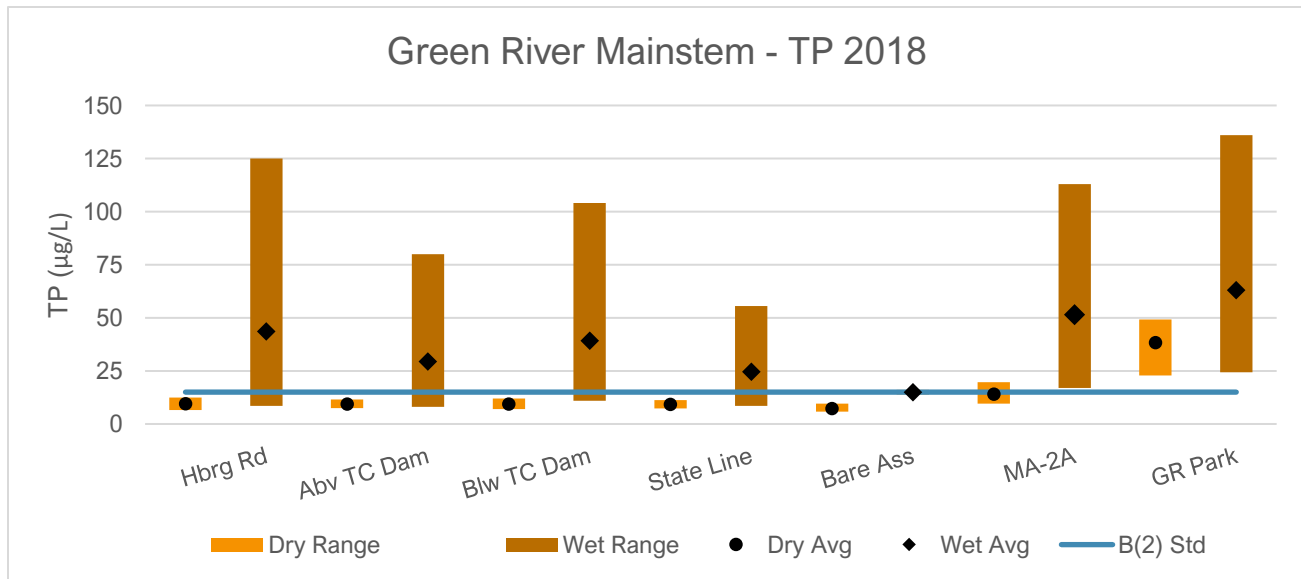
All sites exceeded the VT standard for cold water streams of 15 µg-P/L during wet weather; the Maple Brook and Green River Park sites always exceeded this standard. There are serious erosion issues during wet weather throughout the headwaters of the Green River watershed which is the likely cause of the high phosphorus levels upstream of Greenfield.

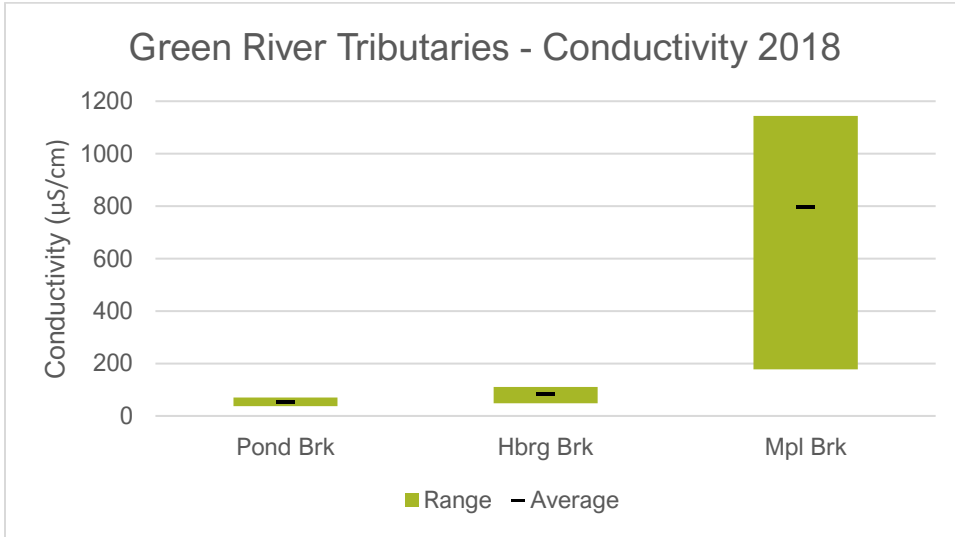
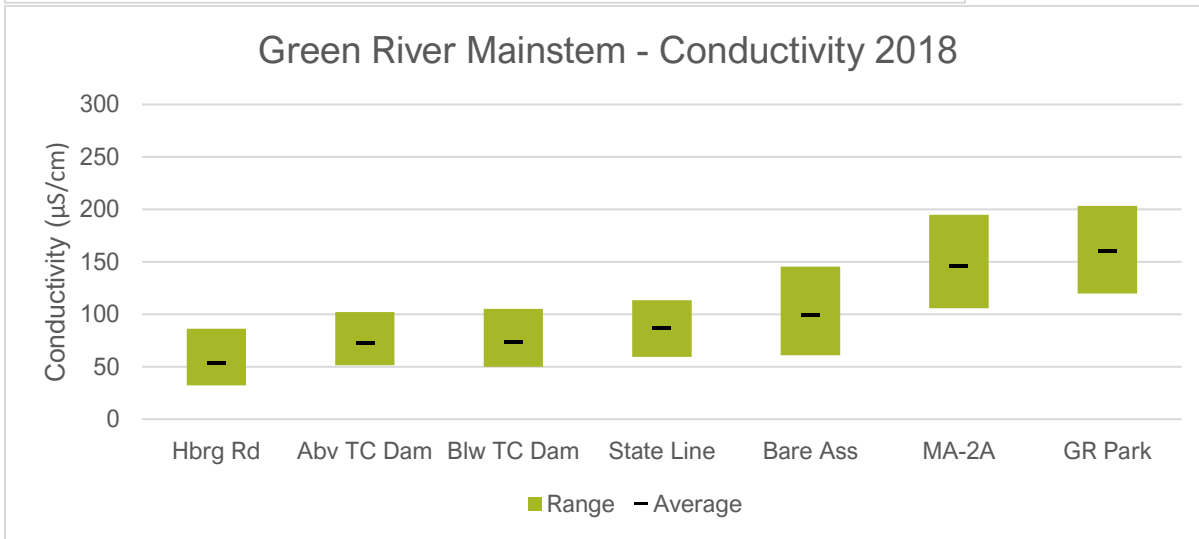
There is no standard conductivity in either state. Ideal conductivity for freshwater streams to support aquatic life is below 1500 µS/cm, which Maple Brook is still below despite being 5-6 times higher than other sites throughout the Deerfield River watershed.

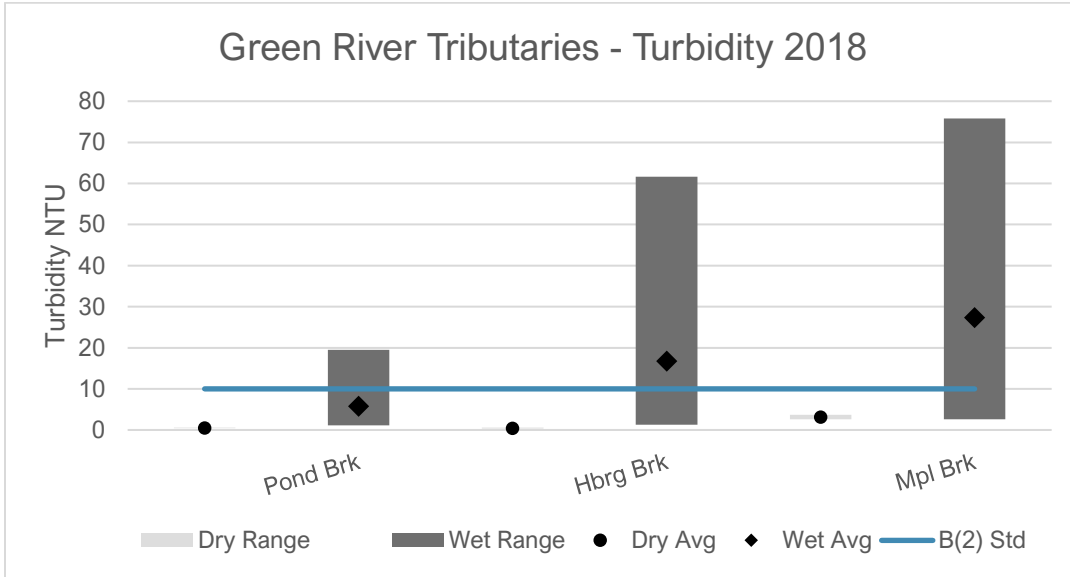
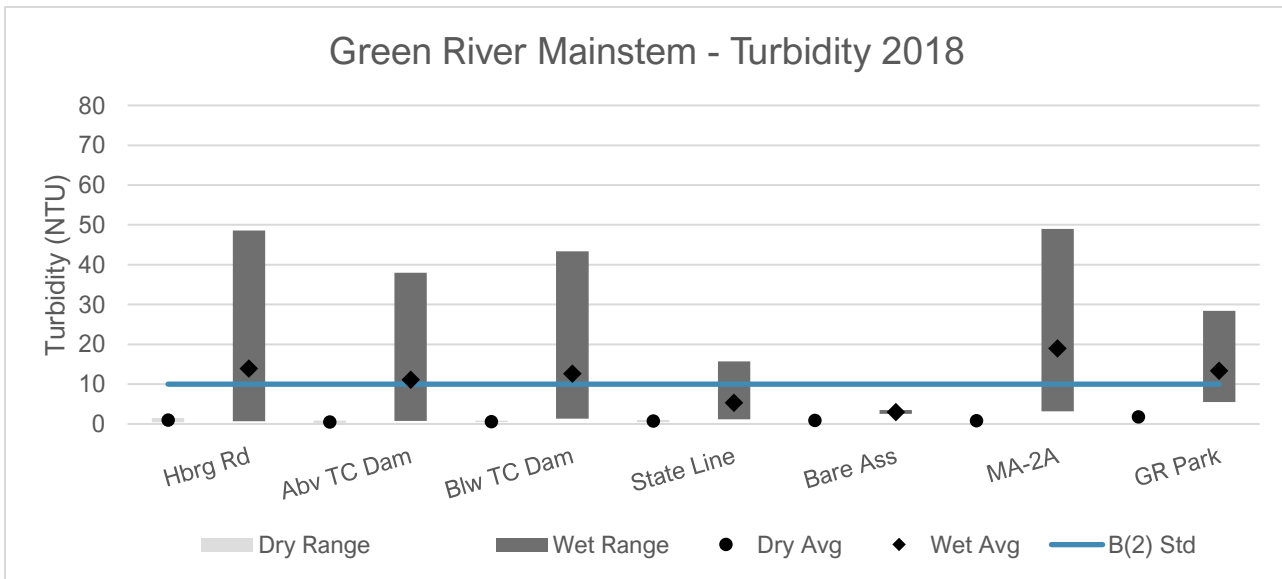
The Green River watershed sites were the only sites consistently monitored for turbidity in 2018. Similar to the total phosphorus results, turbidity was above the Vermont state standard (10 NTU) during wet weather. Unlike other parameters, the turbidity standard is for the year-round average and not just low flow conditions, so it is possible that the Green River and its tributaries is not meeting this standard due to erosion.

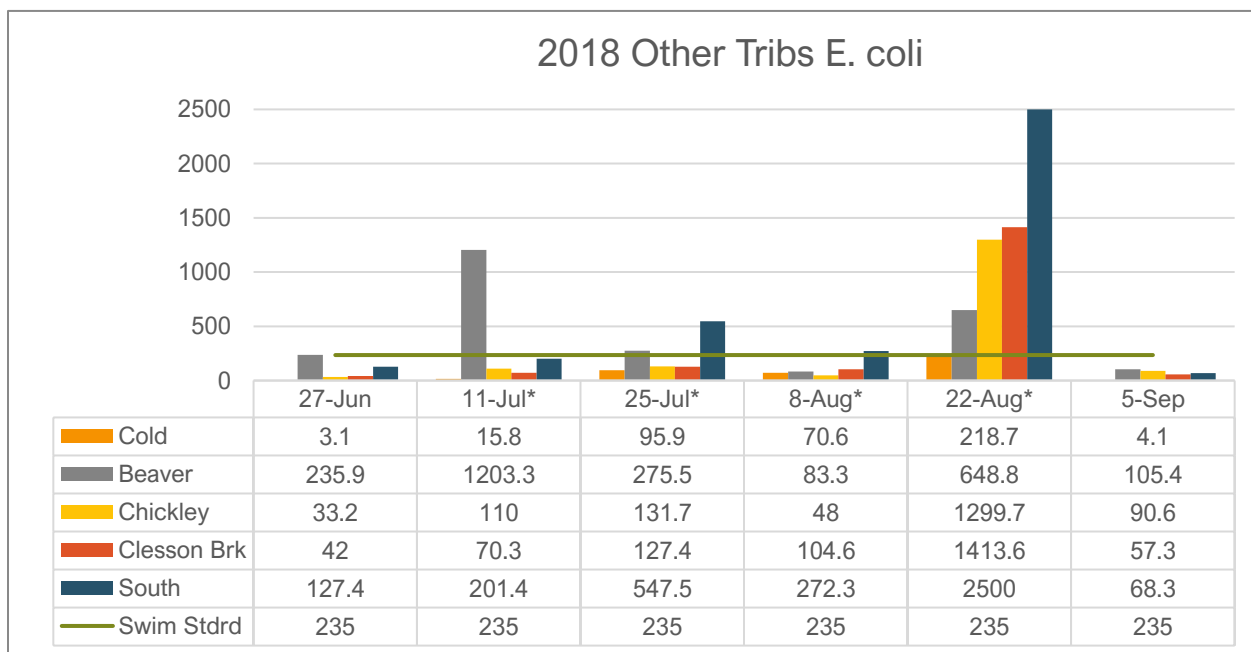
* Wet weather (>0.1" rain) in 24 hours prior to sampling

Like most the watershed, each of these tributaries tended to be below the swim standard in dry weather and were more likely to exceed the standard in wet weather.

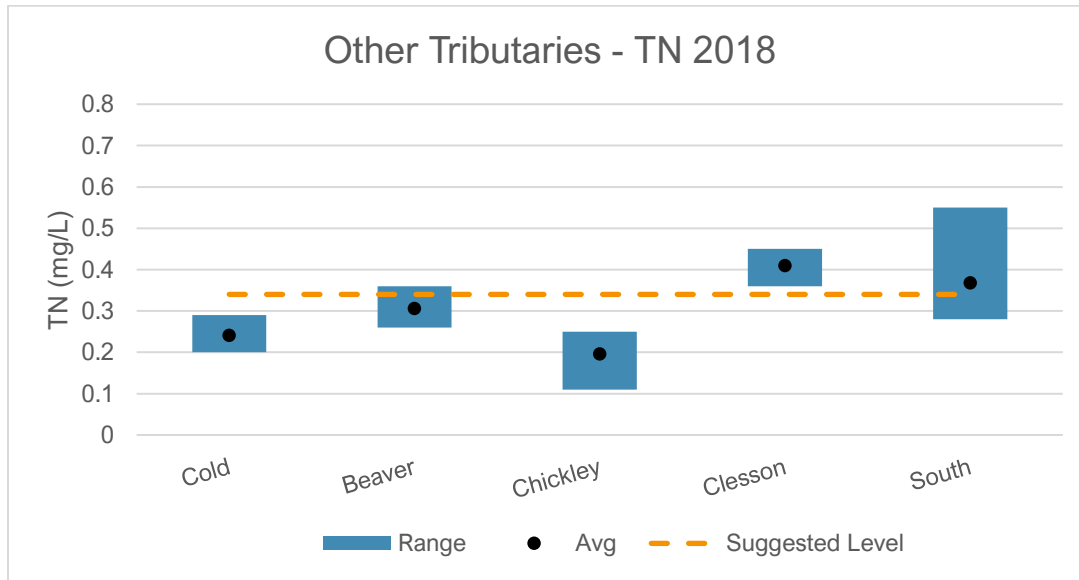
The averages for all these tributary sites were below the VT standard of 5.0 mg-N/L. Both Clesson Brook and the South River sites exceeded the EPA’s current suggested standard of 0.34 mg-N/L; those watersheds both encompass significant agricultural areas.

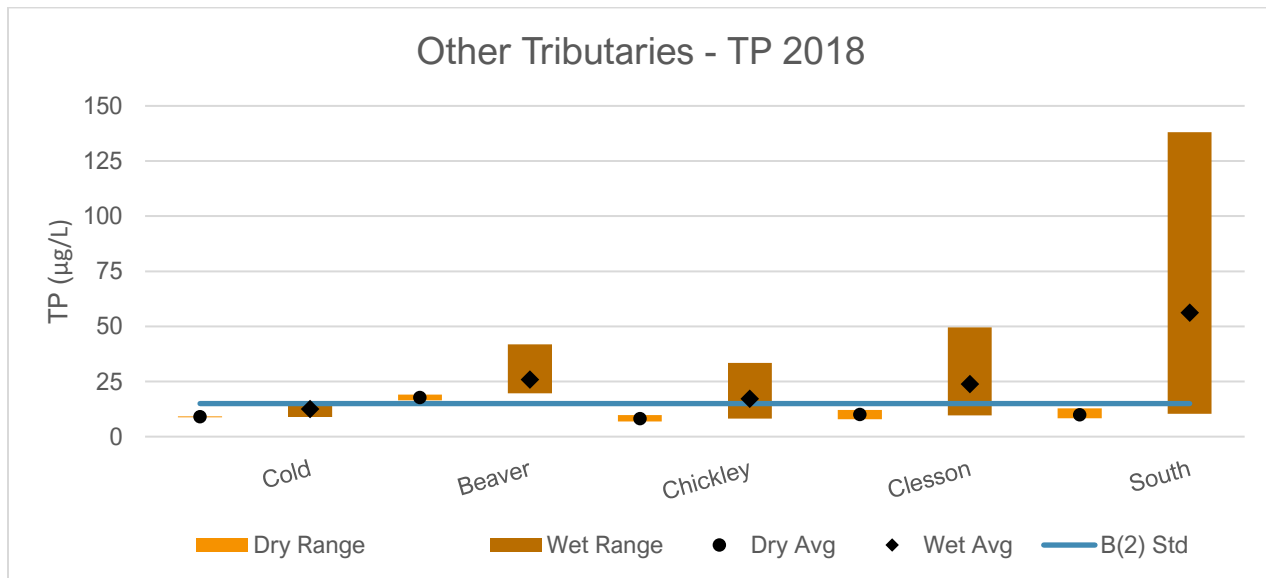
Cold Brook was always below the VT standard for cold water streams of 15 µg-P/L, the Chickley River, Clesson Brook, and South River were below the standard in dry weather but above in wet weather, and the Beaver Brook was always above the standard.

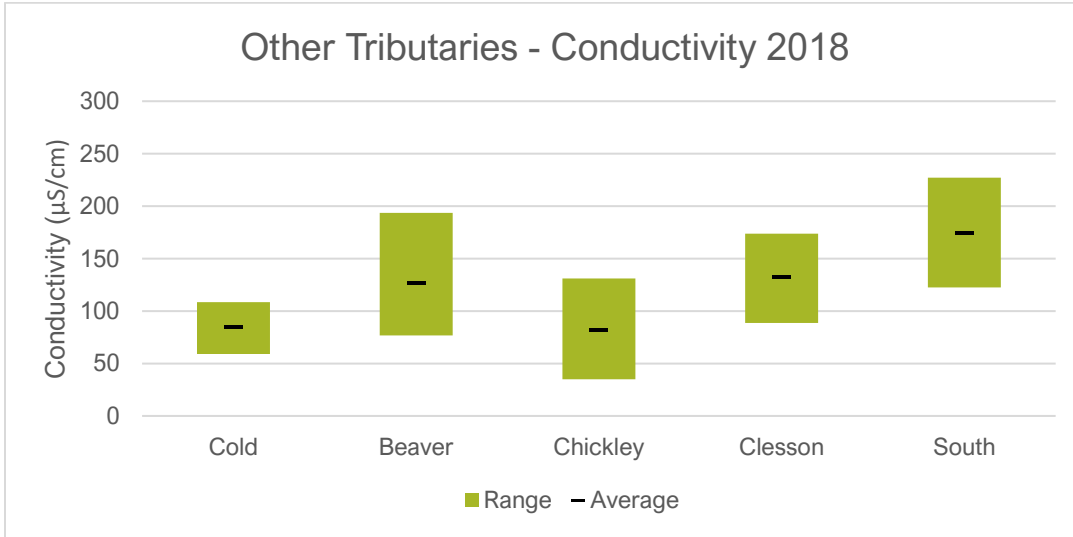
There is no standard for conductivity in either state. No site stands out as particularly impacted.
